Historic Road Bridges

Fingal County Council

Volume 2
Built Heritage &
Ecological Inventory of Bridges

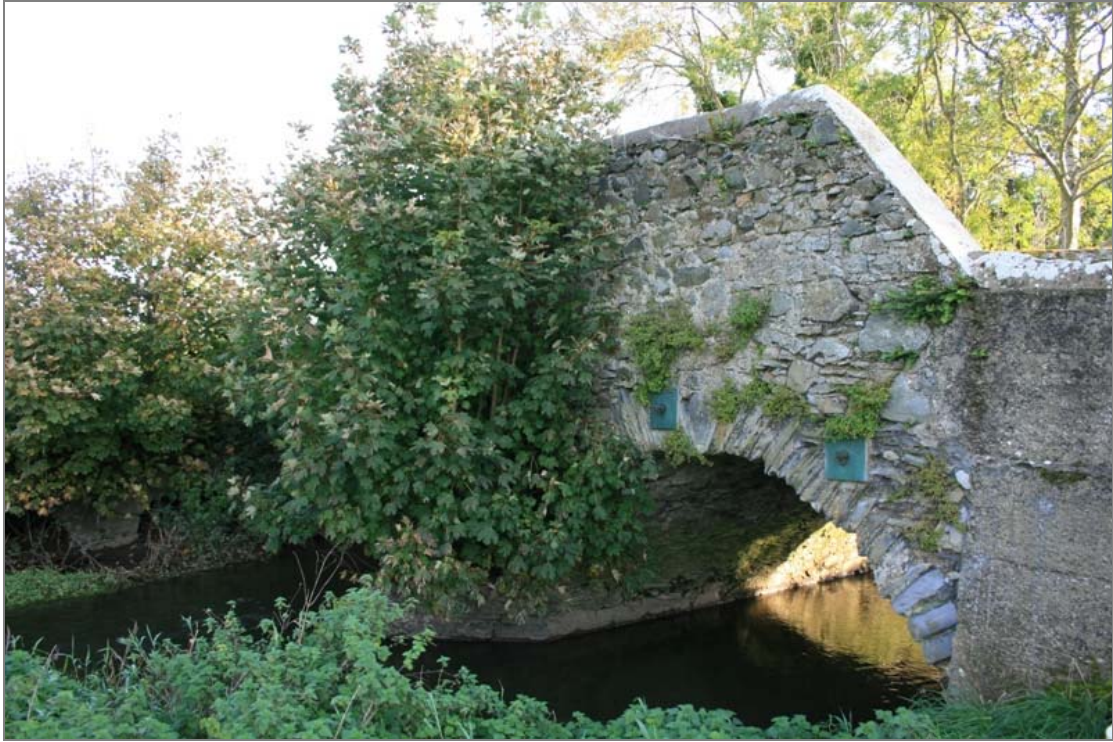
FHBS-01-BH-05 ~ Tree rooted on stone cutwater

- *Recorded Monument (under the National Monuments Code)
Protected Structure (under the Local Government (Planning and Development) Act, 2000).*
- *Repair priorities: - removal of tree growth on the structure

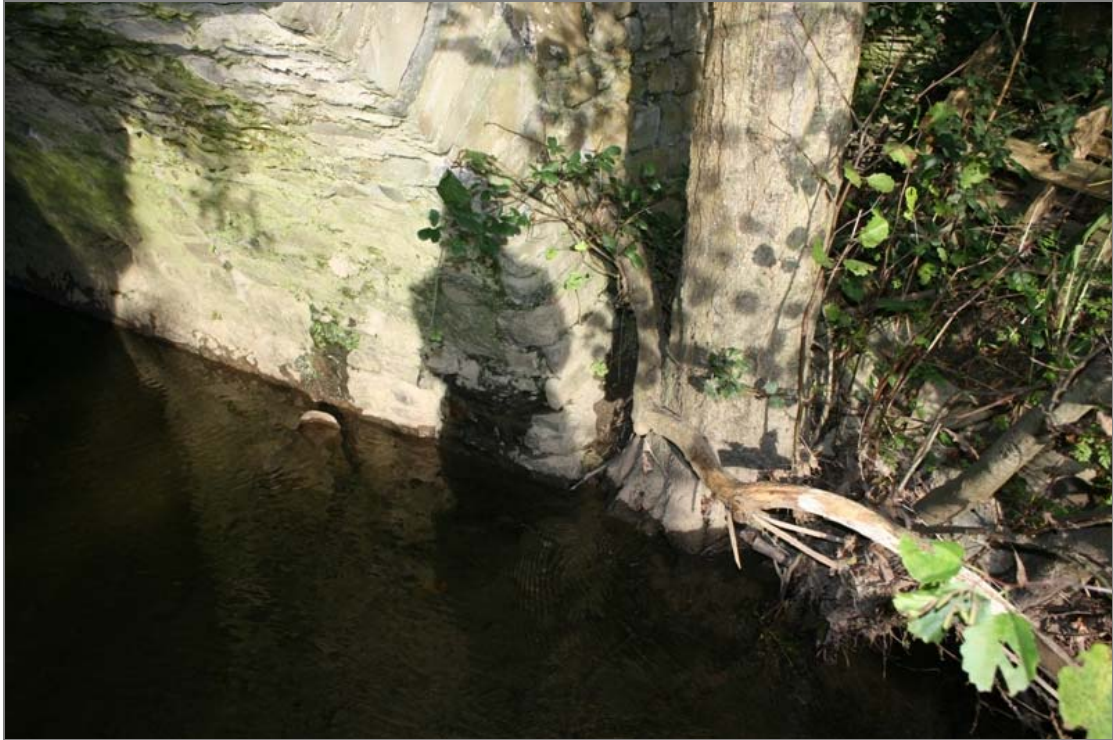
FHBS-01-BH-07 ~ Tree rooted underneath east elevation

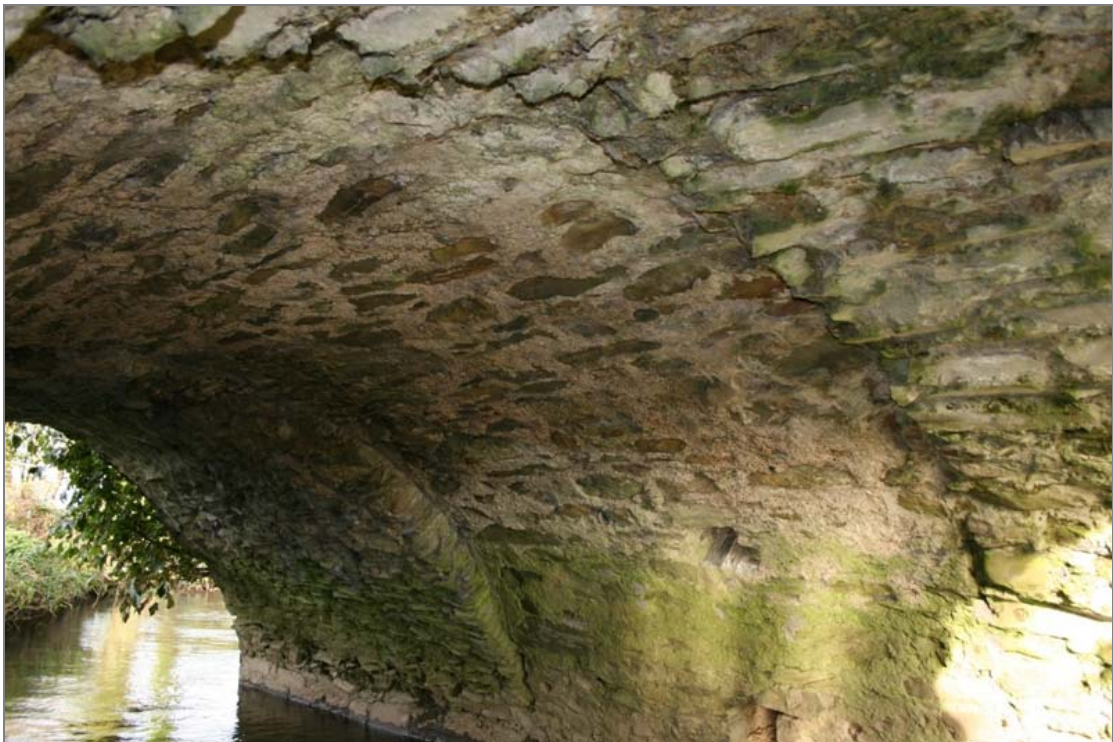
Condition (soffit)	Generally good with little dampness or leaching observed on crown of arch soffit. Some water draining out through joints on lower portion of arch soffit.
Grouting or spray concrete?	No
Grouting or spray commentary	n/a

FHBS-01-BH-08 ~ Soffit of southern arch from east

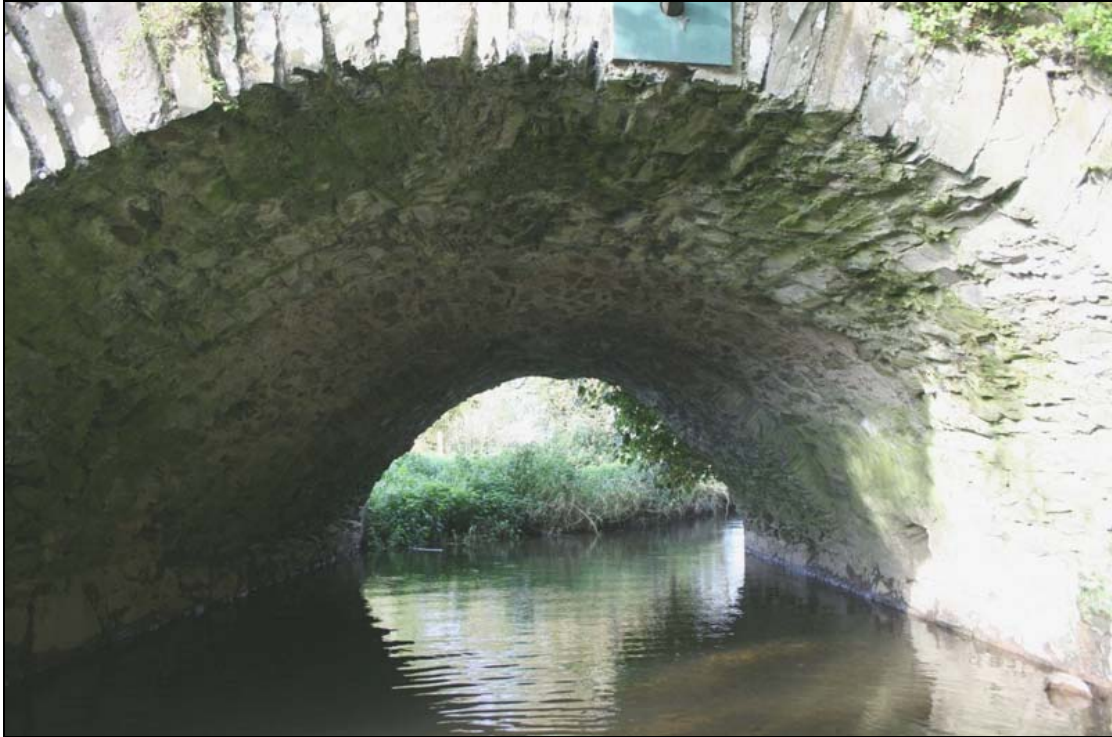
FHBS-01-NH-01 ~ Bridge underarch with crevices – Bat roosting potential

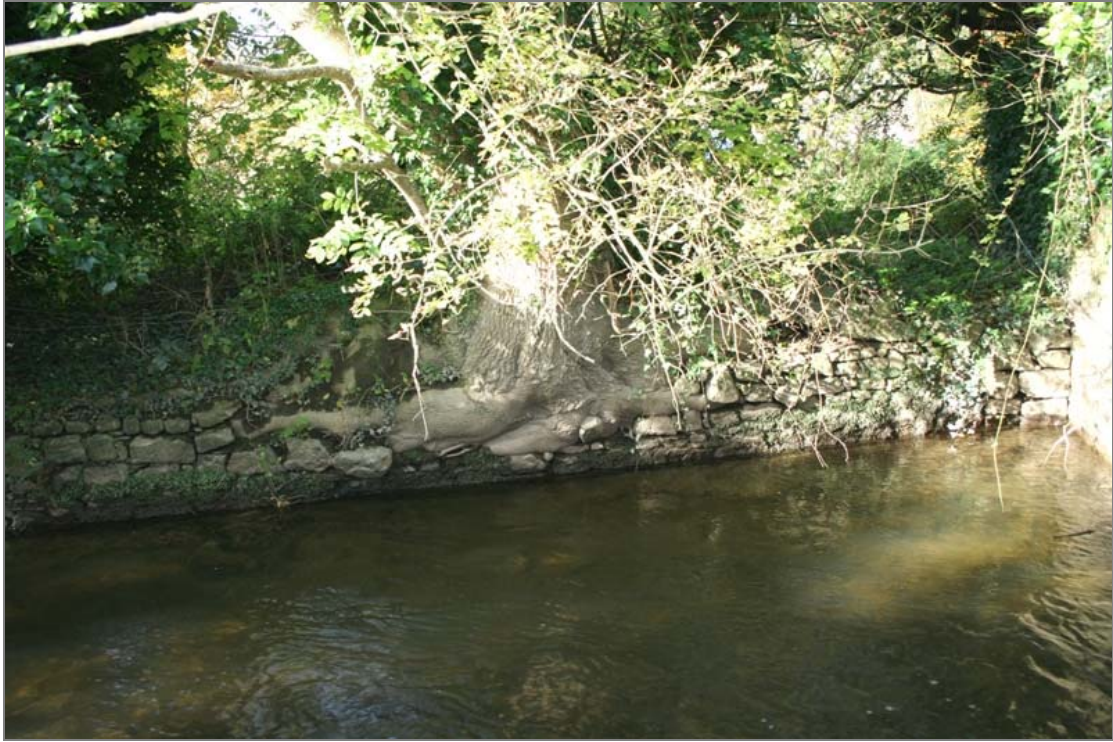
FHBS-02-BH-04 ~ Large Ash tree rooted on stone-built west bank just upstream of south elevation

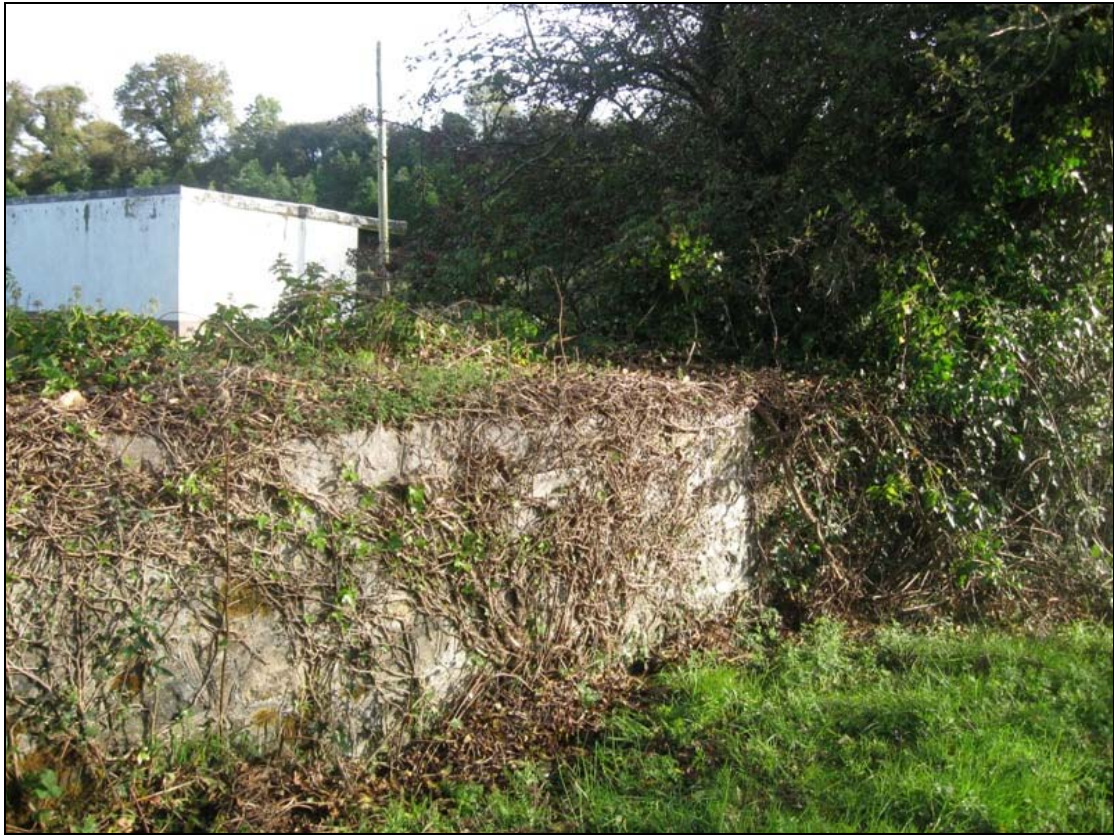
FHBS-02-NH-01 ~ Ivy coverage on bridge parapet

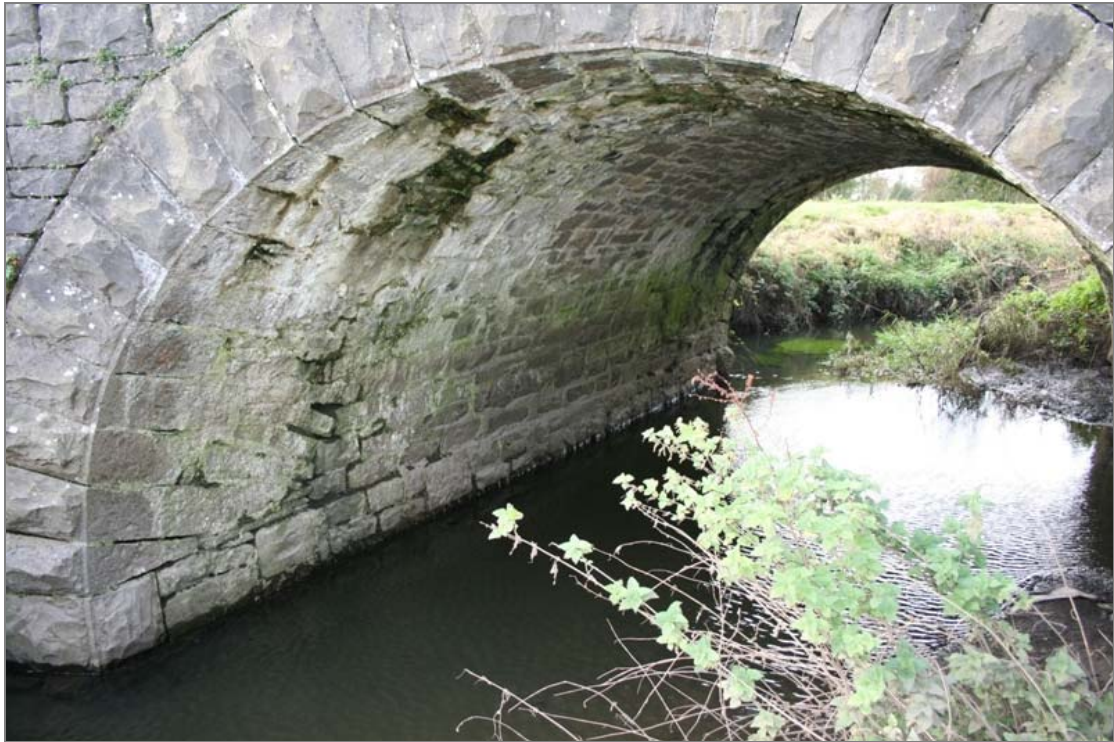
FHBS-03-BH-07 ~ Soffit of arch from east

Historical background	6-10-87 survey report stated that some voussoirs on the south west corner of the bridge had slipped slightly, opening up a crack in the soffit about 1.5m from the edge of the arch.
References (i.e. historical, bibliographical)	None found
Date of construction	1880
Principal material	Squared limestone
Condition (structural)	Good
Condition (parapet)	Generally good but with some repairs to parapet coping involving replacement of coping stones with cast concrete and re-use of coping stones from elsewhere.
Condition (matrix/mortar)	Generally good but pointing required to all exterior as surface mortar joints have generally weathered away with some face stones having already fallen out.
Condition (soffit)	Some areas of dampness in soffit but generally in good condition with lower joints requiring pointing and some crystallisation of minerals in mortar at arch crown.
Grouting or spray concrete?	No

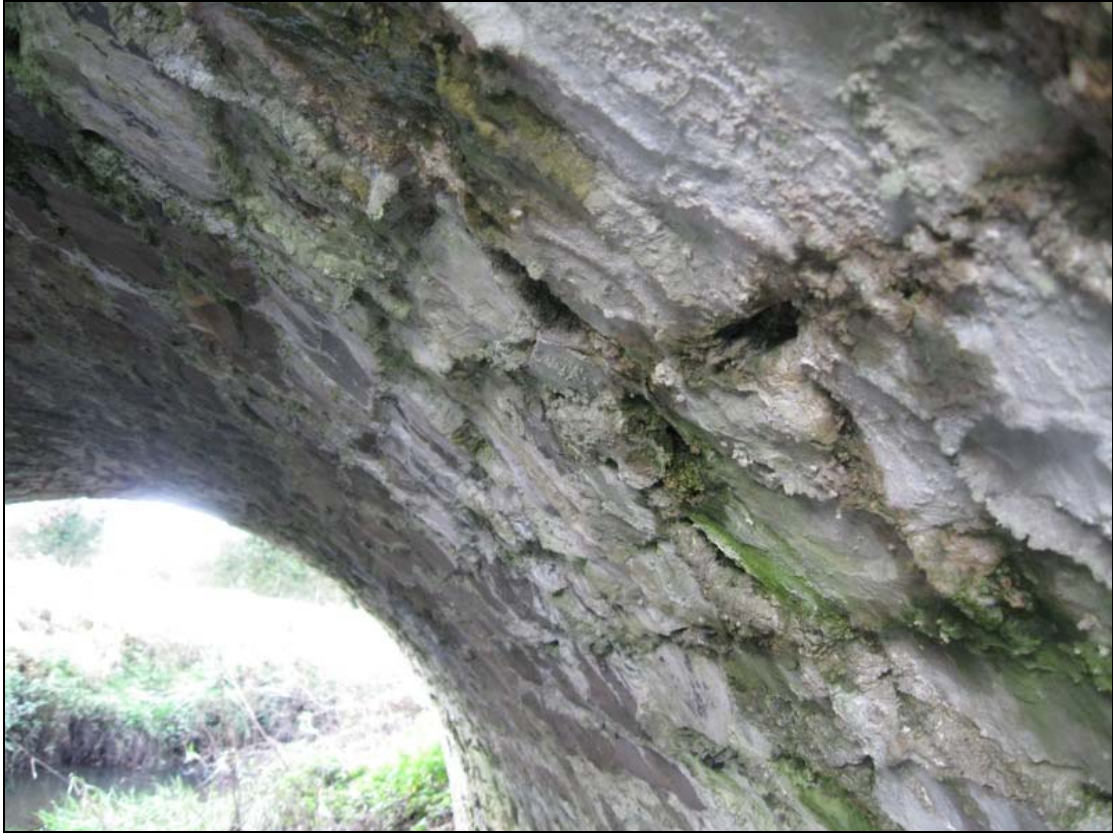
FHBS-03-NH-01 ~ Crevices on bridge – bat roosting potential

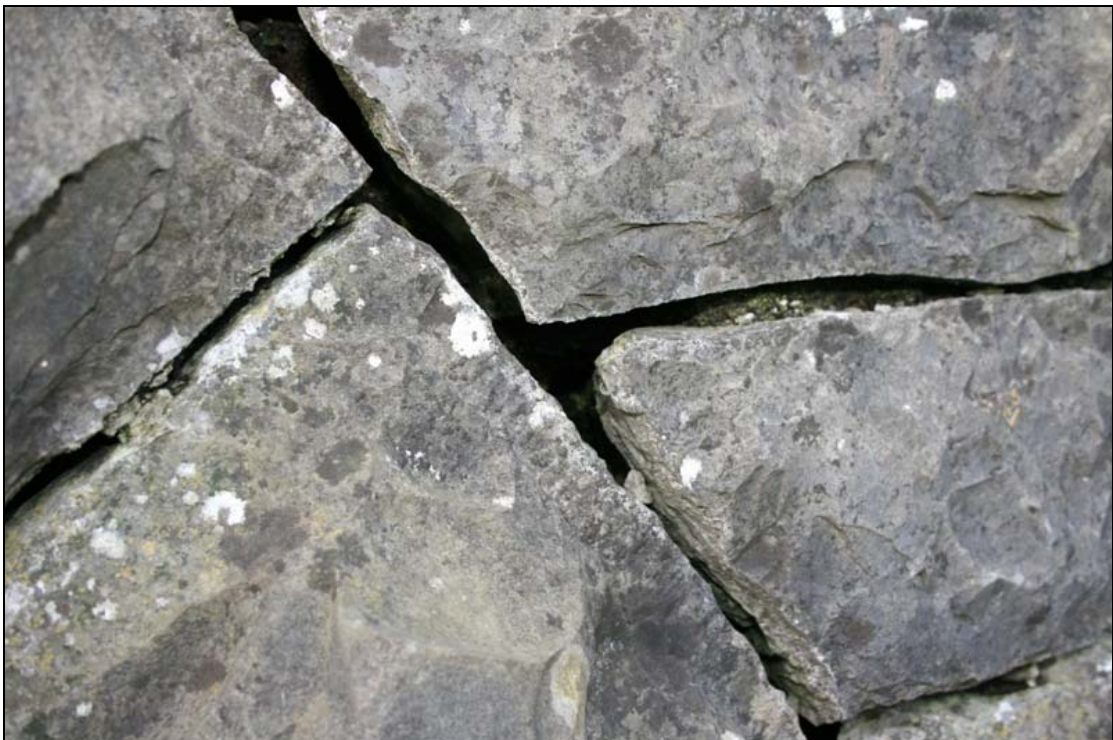
FHBS-03-NH-02 ~ Crevices in parapet wall

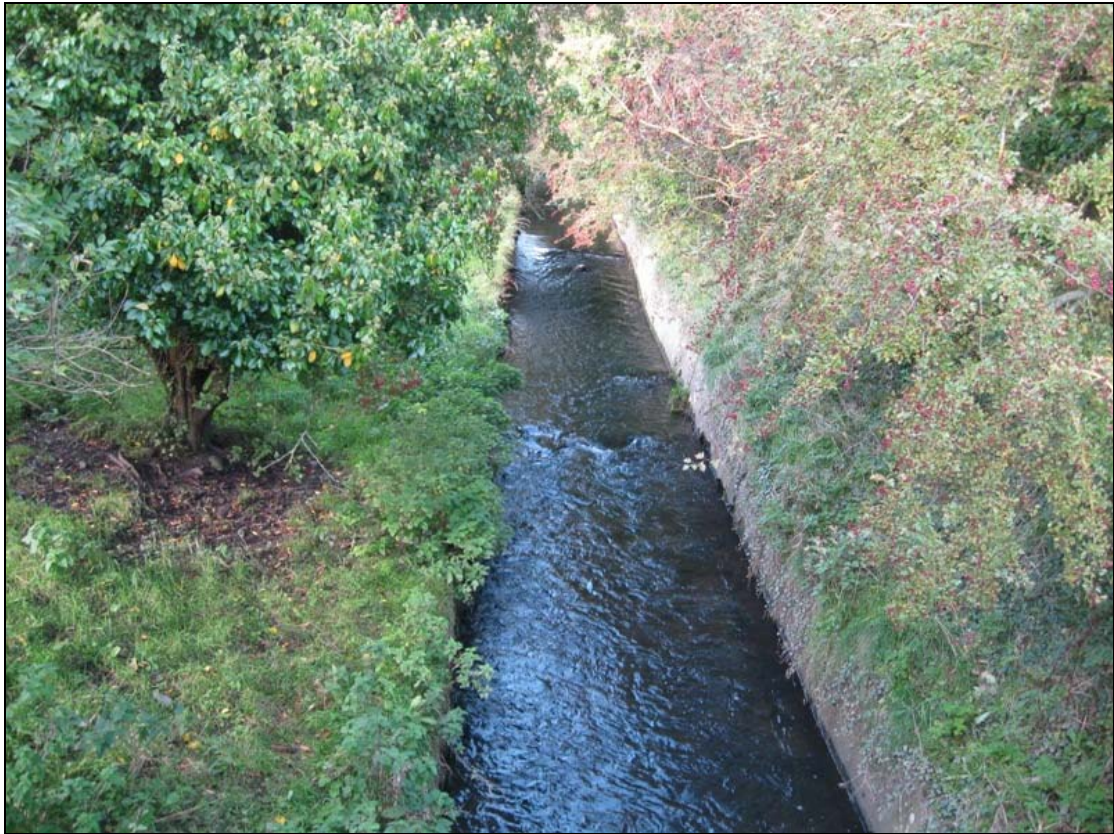
FHBS-04-NH-01 ~ Channelised stream flowing under bridge

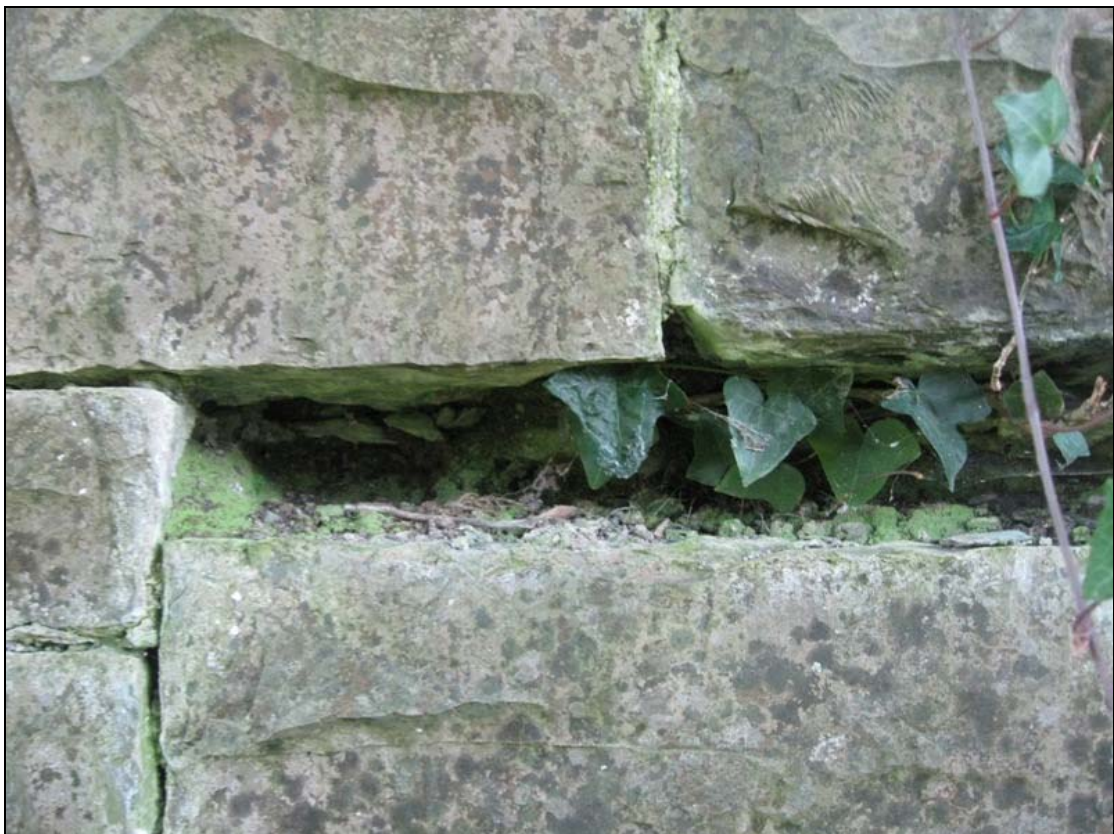
FHBS-04-NH-04 ~ Structural breakdown of parapet wall

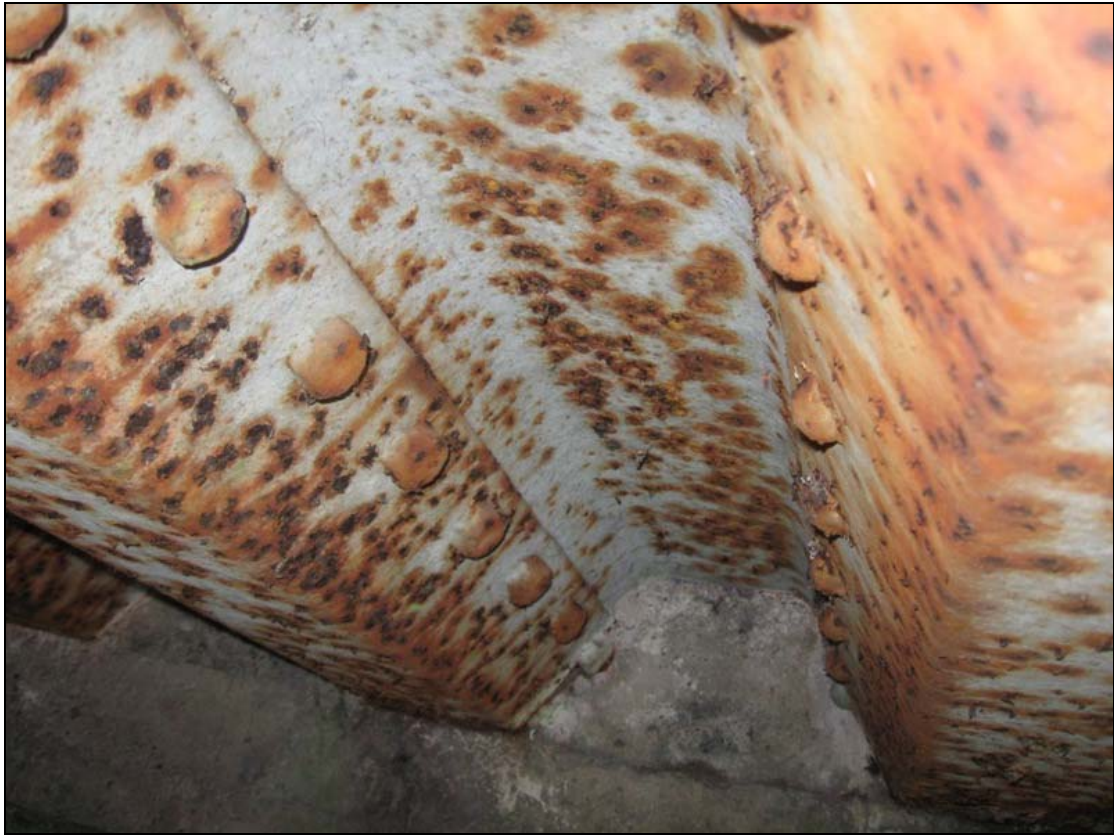
FHBS-05-NH-01 ~ Bridge underarch unsuitable for bat activity

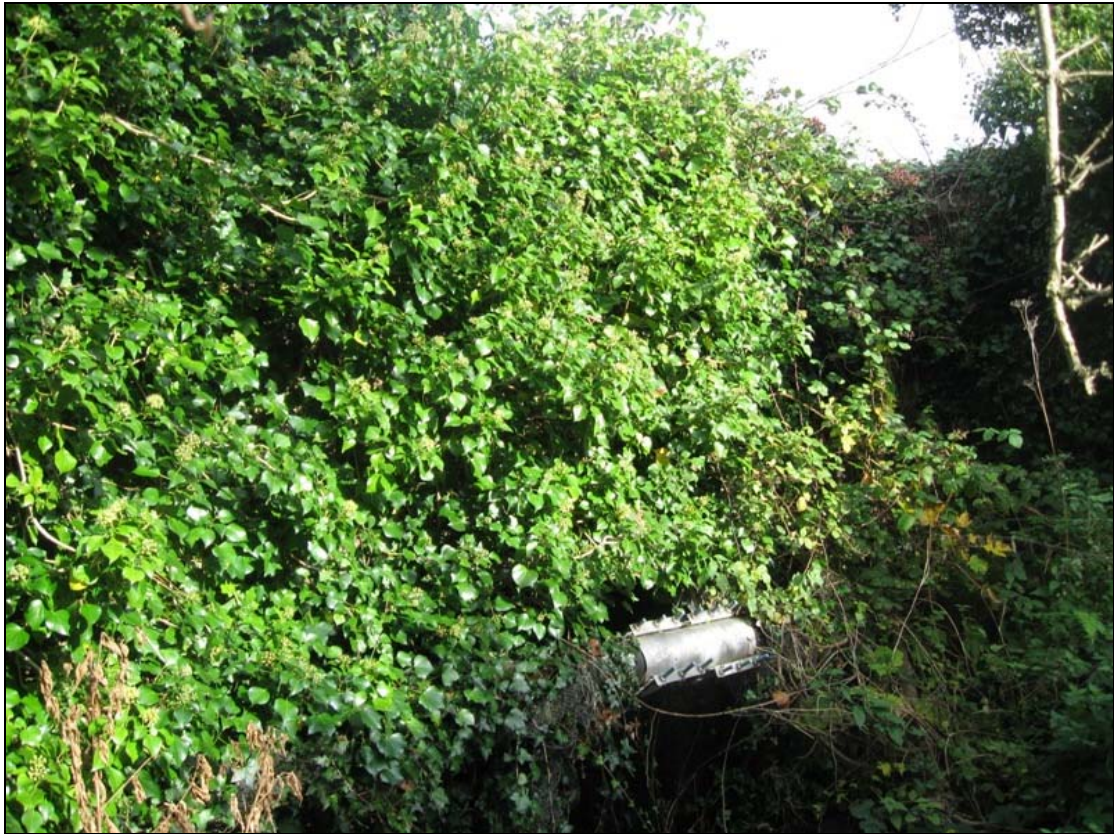
FHBS-05-NH-03 ~ Ivy on downstream parapet wall

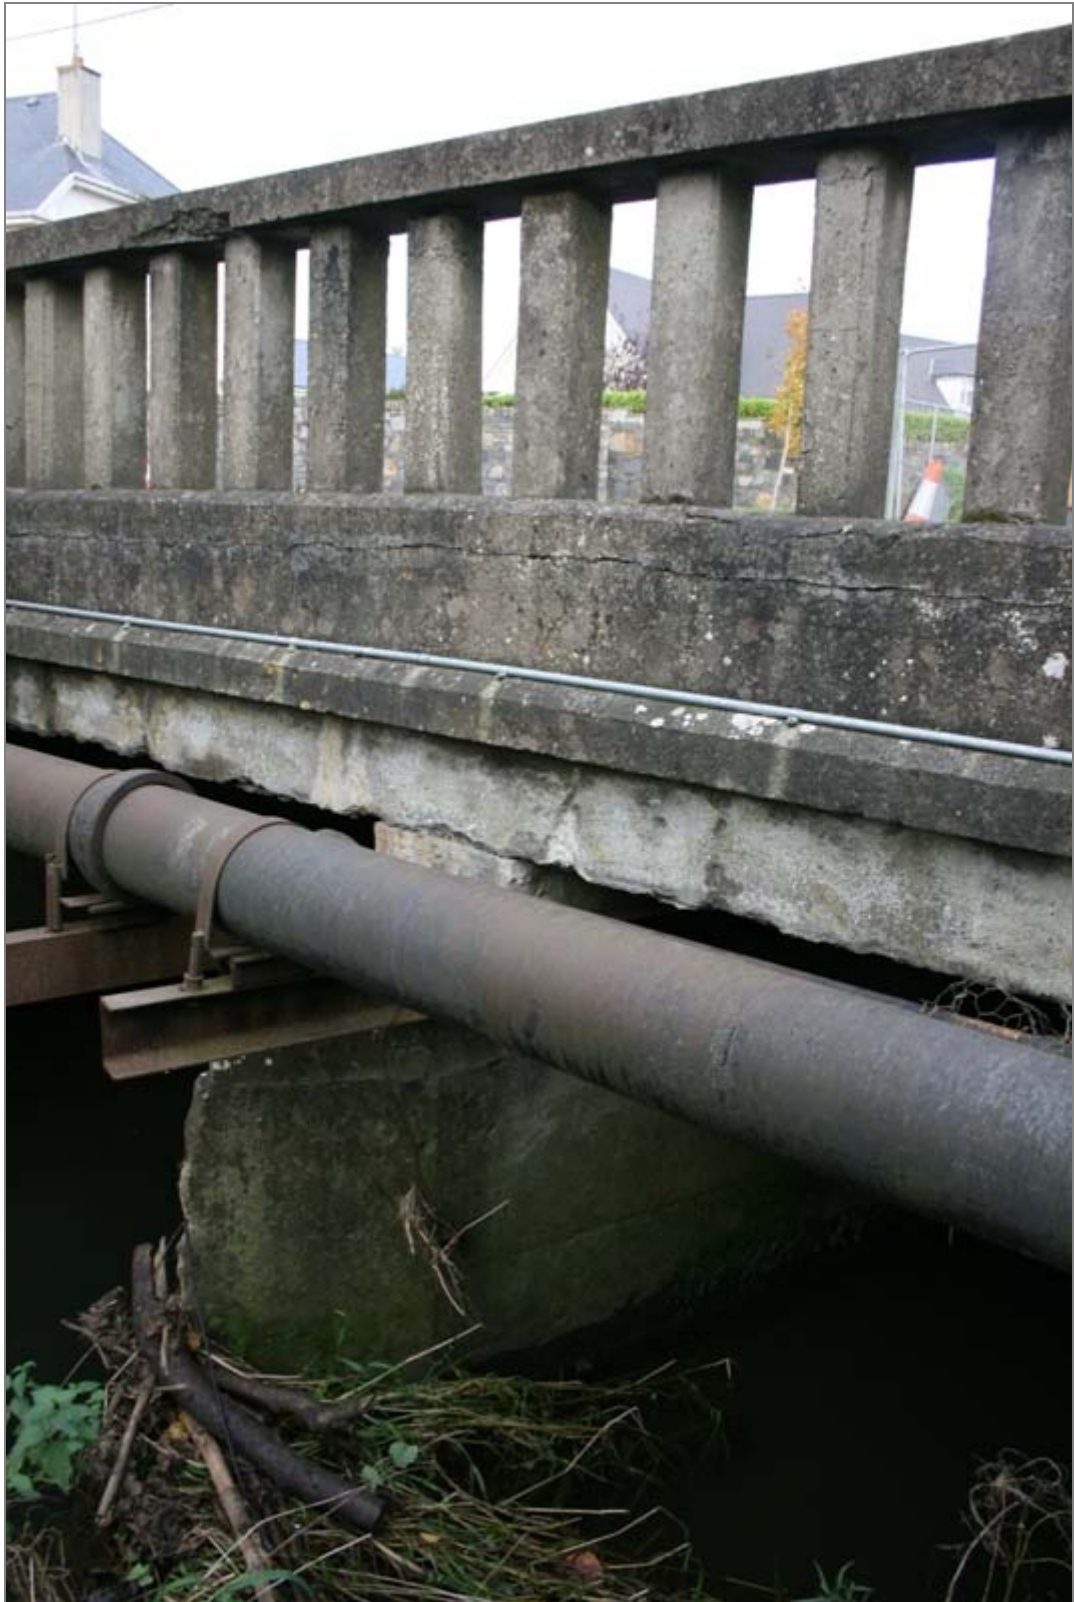
visible on west elevation.
Condition (parapet)	West parapet displays multiple cracks on plinth, balustrade and handrail. East parapet being reconstructed in steel-reinforced cast concrete.
Condition (matrix/mortar)	Fully cast concrete construction.
Condition (soffit)	Good
Grouting or spray concrete?	No
Grouting or spray commentary	n/a
Accessibility	Only south bank of west side accessible with excessive vegetation and marsh restricting access to north bank. East side accessible on north bank but blocked to southern bank by scaffolding and stream.
Built heritage photographs	FHBS-06-BH-01 ~ West upstream elevation FHBS-06-BH-02 ~ East downstream elevation FHBS-06-BH-03 ~ West parapet from upstream FHBS-06-BH-04 ~ East parapet from road FHBS-06-BH-05 ~ Name plaque on west parapet FHBS-06-BH-06 ~ Replacement, reinforced cast concrete balusters to east parapet. FHBS-06-BH-07 ~ Soffit of southern arch from west

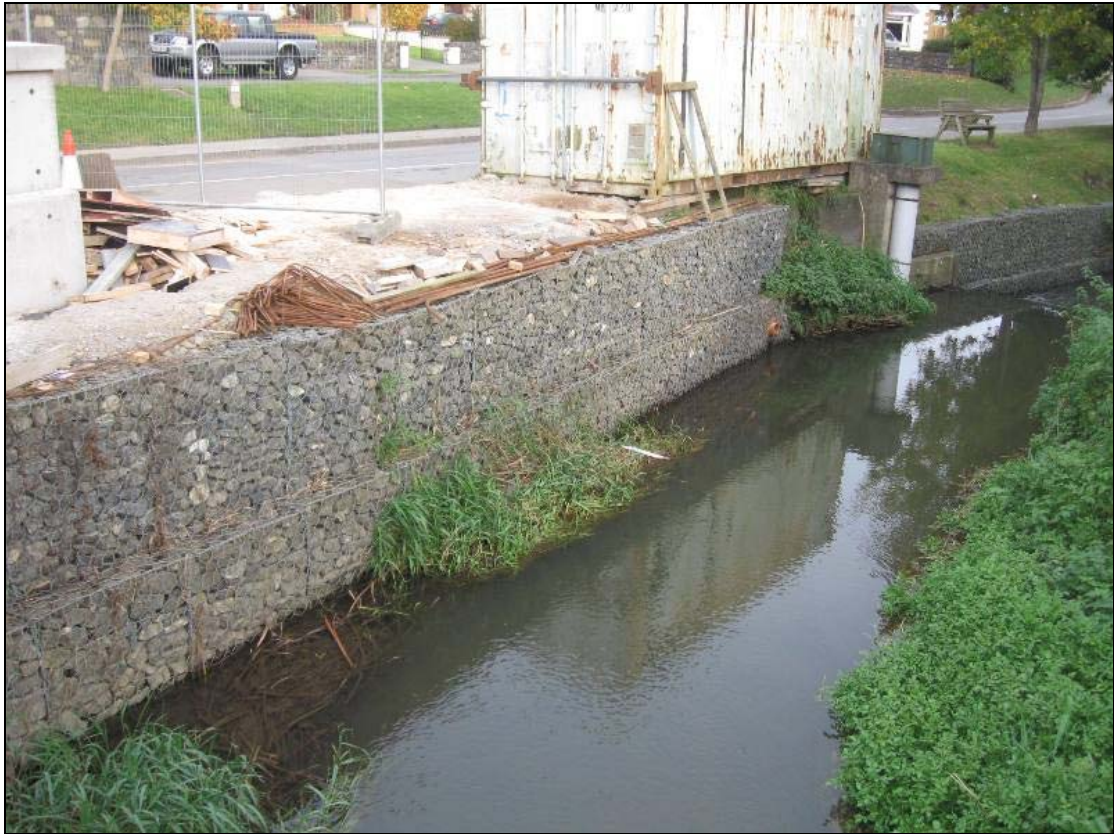
FHBS-06-NH-02 ~ Gabion structures on downstream bank

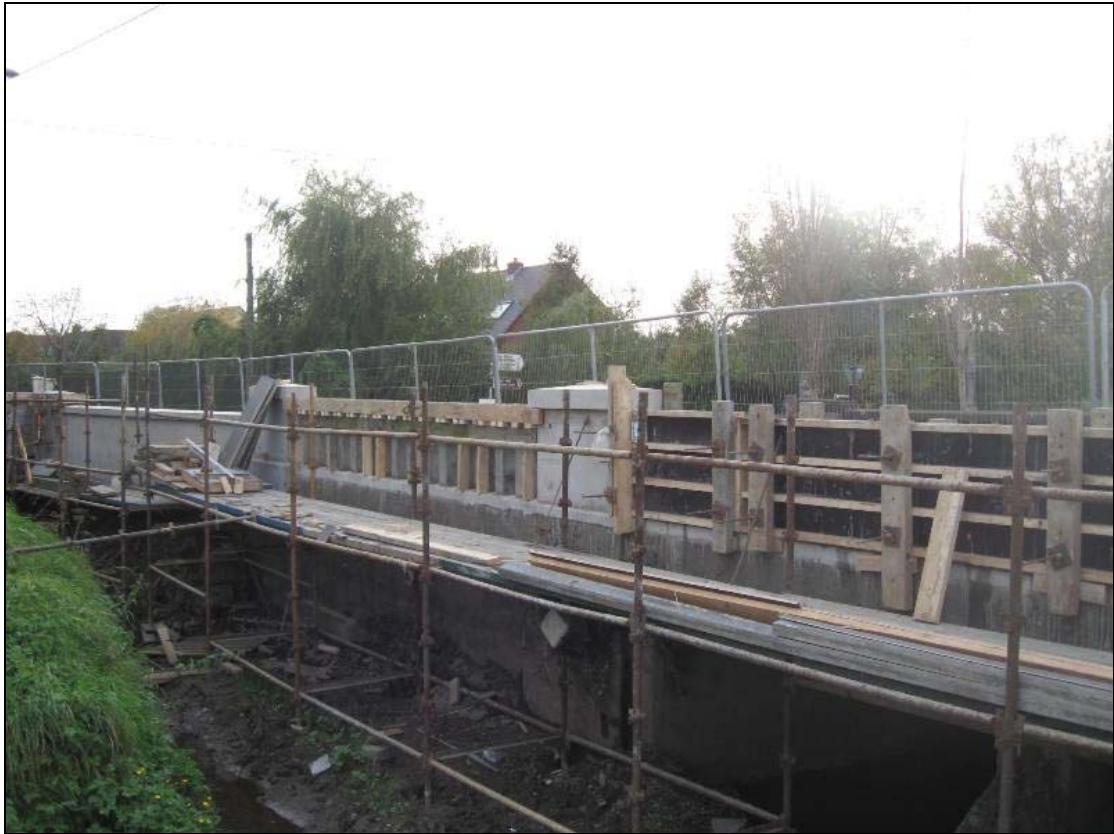
FHBS-06-NH-04 ~ Ongoing construction on downstream parapet

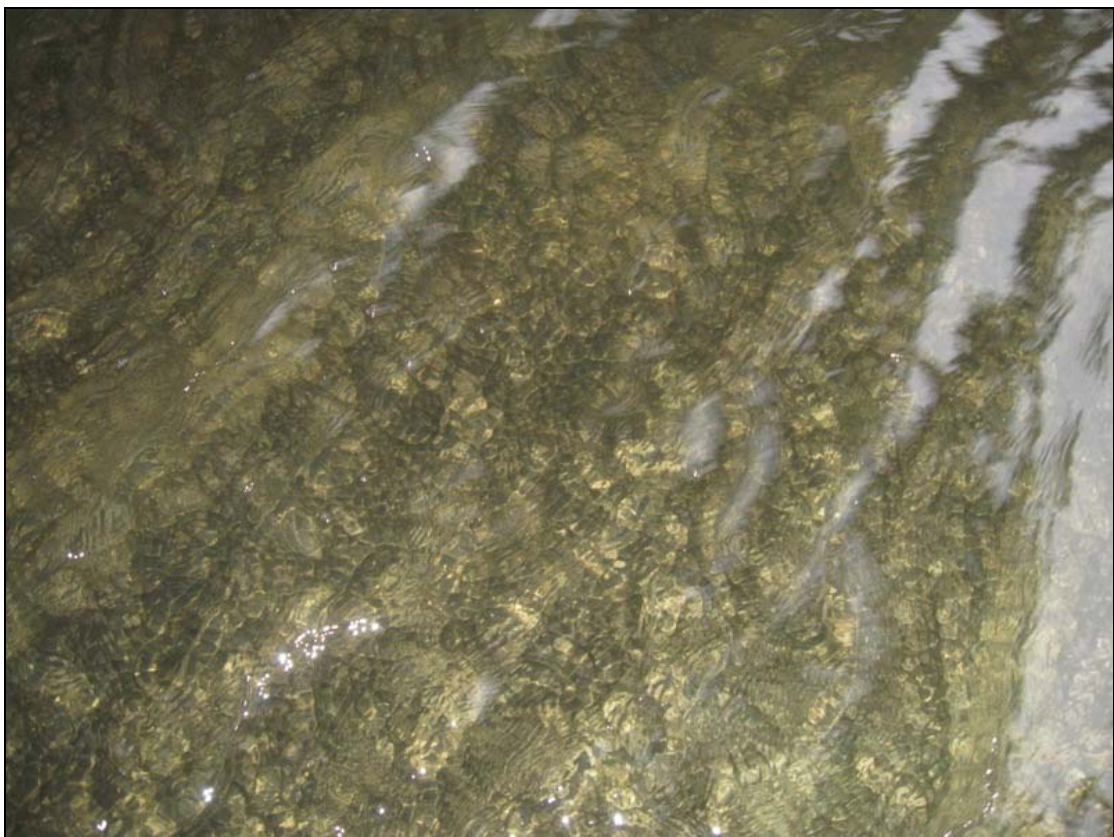
FHBS-07-NH-02 ~Concrete substrate underneath bridge arch

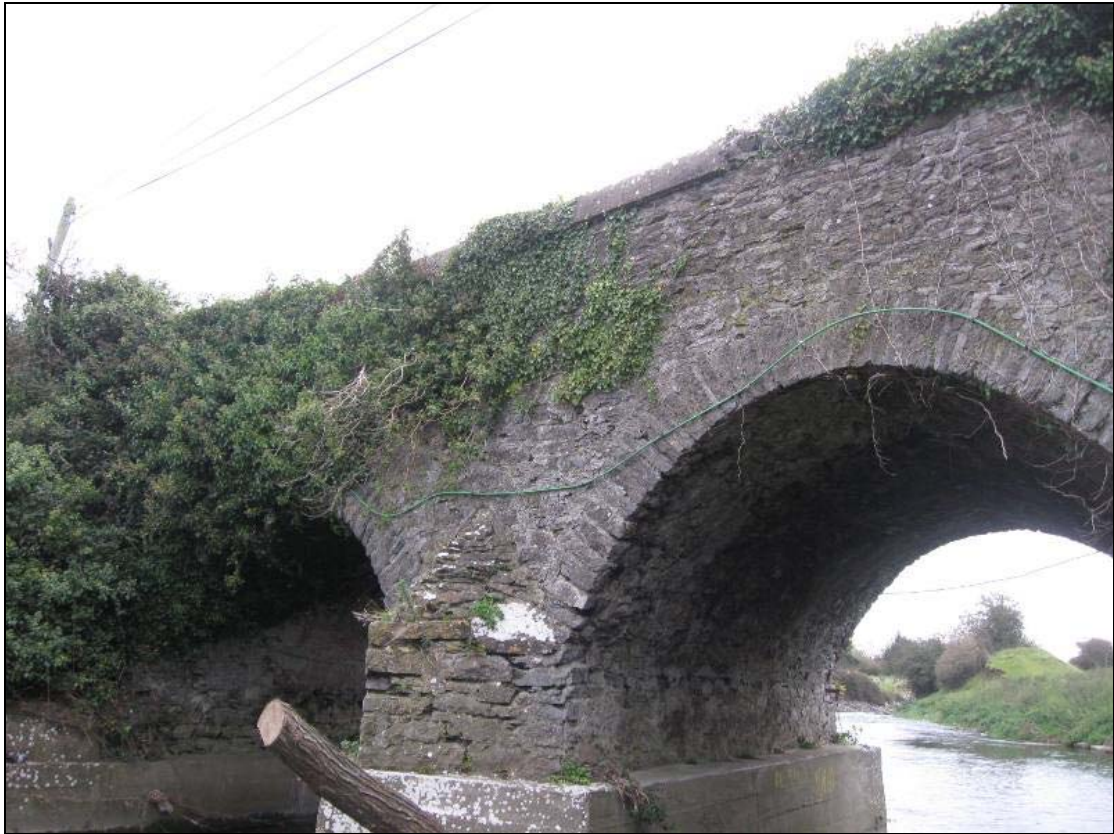
FHBS-07-NH-03 ~ Ivy cover on downstream side of the bridge

- appropriate repairs required should be in lime mortar
- removal of ivy rooted on masonry, retaining ivy cover as a habitat where no structural damage is being caused*

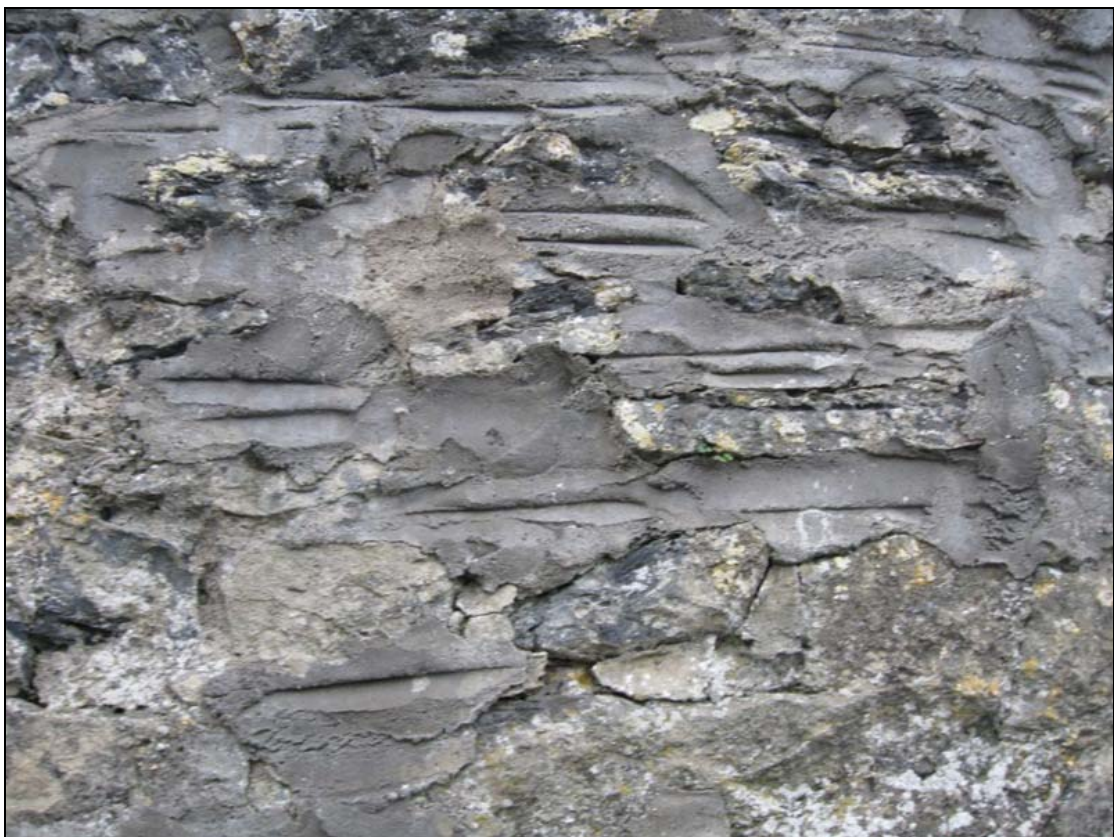
elevations and to a lesser extent under the arches. This can restrict the natural drainage of the bridge and is to be avoided.
Condition (soffit)	Good
Grouting or spray concrete?	No
Grouting or spray commentary	n/a
Accessibility	Accessible from all sides
Built heritage photographs	FHBS-08-BH-01 ~ West upstream elevation FHBS-08-BH-02 ~ East downstream elevation FHBS-08-BH-03 ~ West parapet from road FHBS-08-BH-04 ~ East parapet from road FHBS-08-BH-05 ~ Re-built stone cap of western cutwater FHBS-08-BH-06 ~ Central opening of 5 arch bridge looking upstream FHBS-08-BH-07 ~ Dry arch on southern bank from eastern side FHBS-08-BH-08 ~ View upstream to west
Name of Built Heritage Field Surveyor	Eamonn Hunter
Date of inspection (Built Heritage)	22-10-08
Built heritage commentary	<p>This well constructed bridge has been in place on this site for at least 300 years and still retains much of its original appearance. It is of regional significance with archaeological, architectural and technical interest. The use of cement to repair pointing mortar is to be discouraged as an irreversible technique using a material that prevents the natural drainage of the bridge structure through joints rather than individual stones. The absence of grass verges on the bridge tops and the present good drainage of the road surface prevents excessive moisture entering the structure but appropriate lime mortar for pointing is still the best way to ensure this bridge's long term survival.</p> <p>Previously surveyed 1-7-80; 8-10-87</p>

FHBS-08-NH-04 ~ Repointed parapet wall

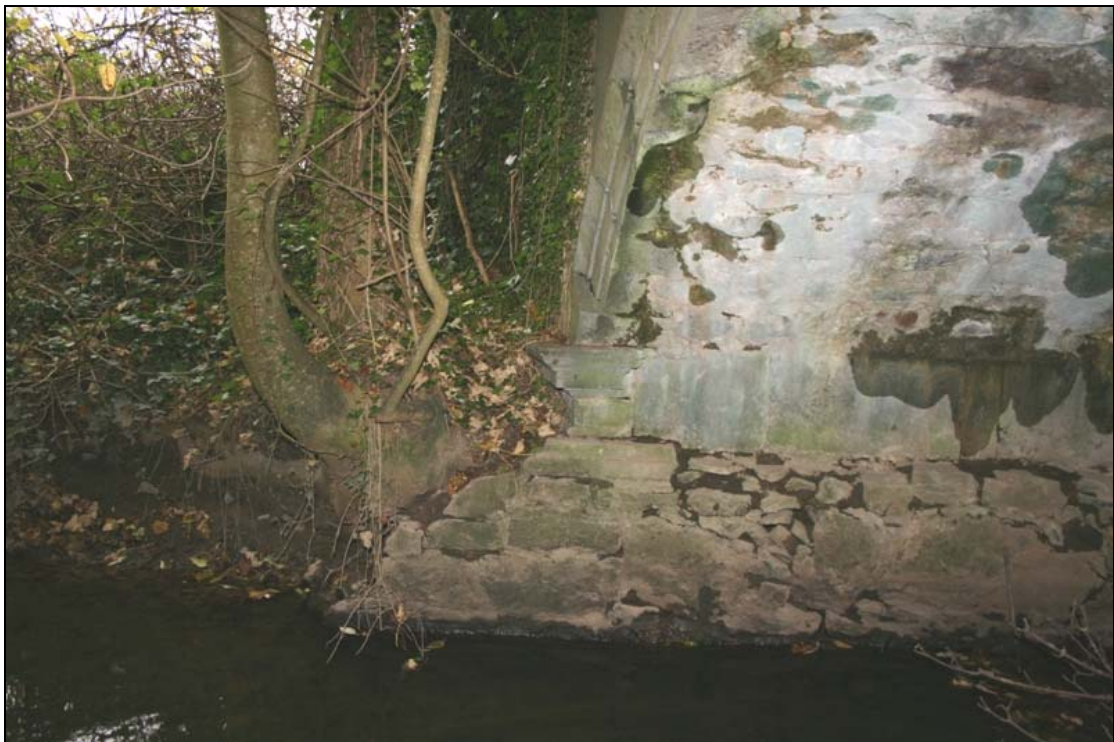
FHBS-09-BH-05 ~ Tree rooted on stone abutment on north bank of west side

- *The issue of trees rooted within or adjacent to the structure should be monitored for any interference that these may be having with the structure. They may need to be removed before damage to the bridge occurs.*

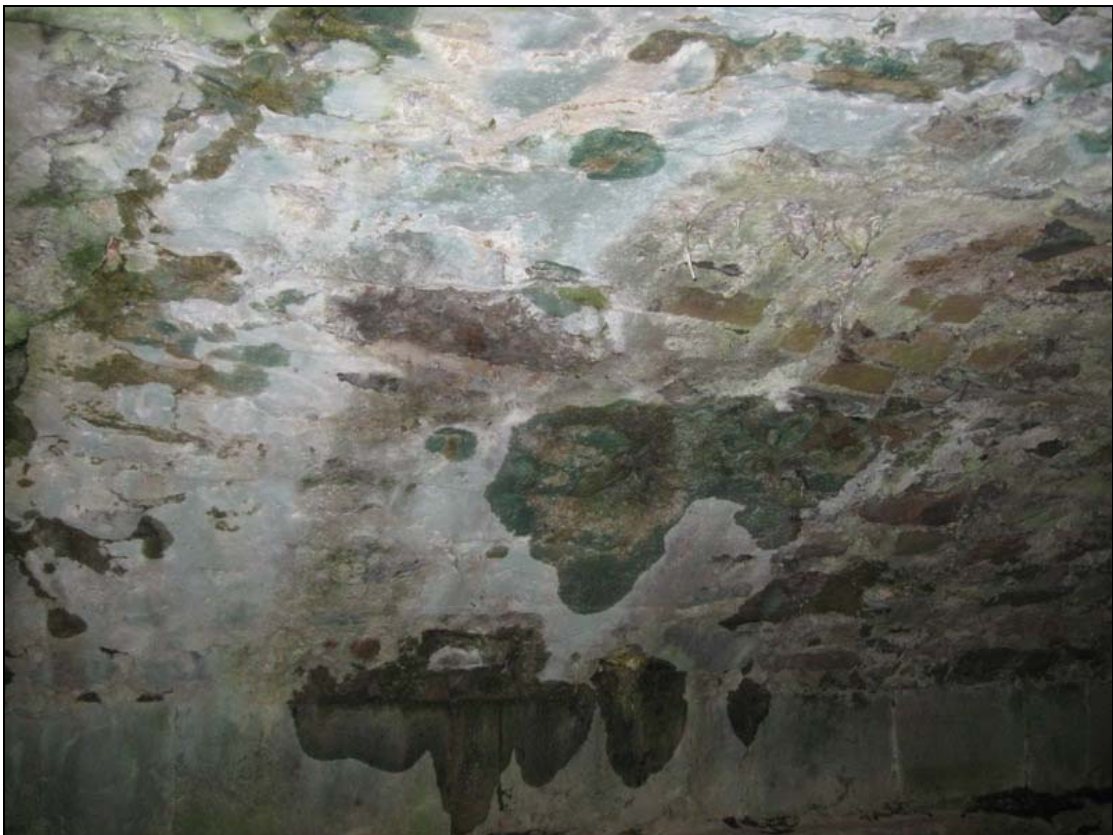
FHBS-09-NH-02 ~ Bridge underarch - lack of crevices

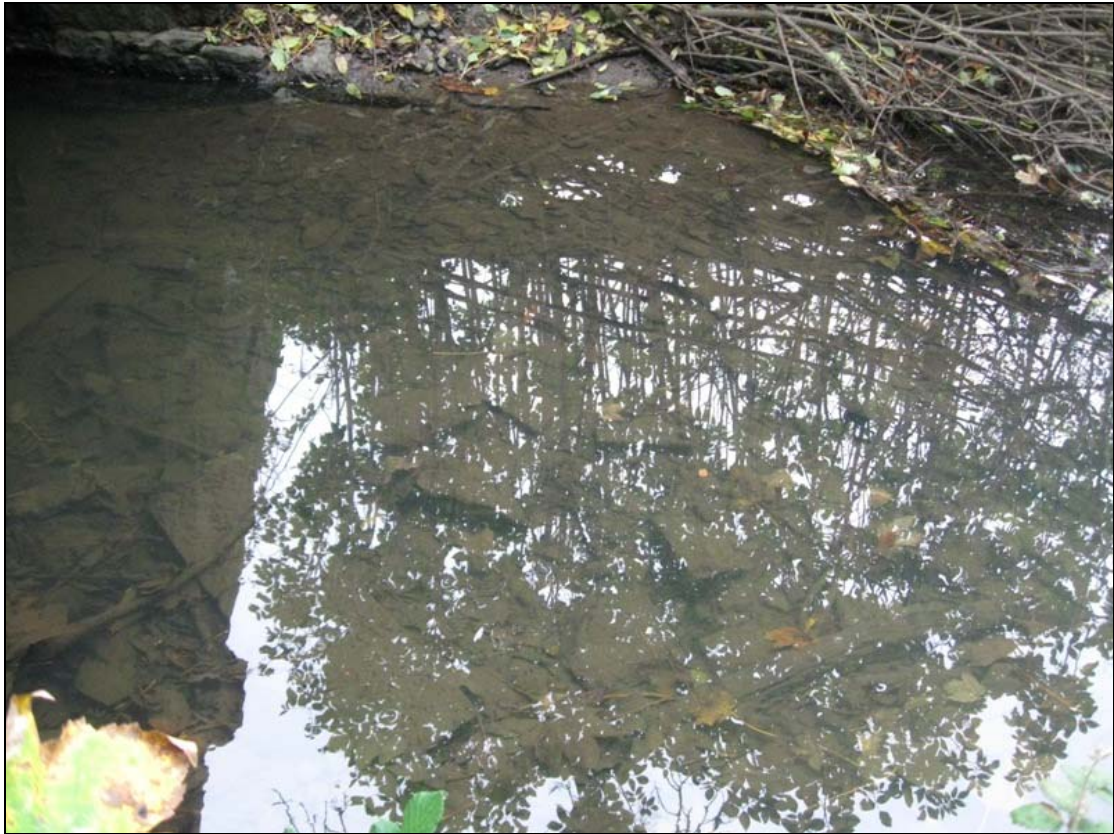
FHBS-09-NH-05 ~ Stream substrate - build up of silt and detritus

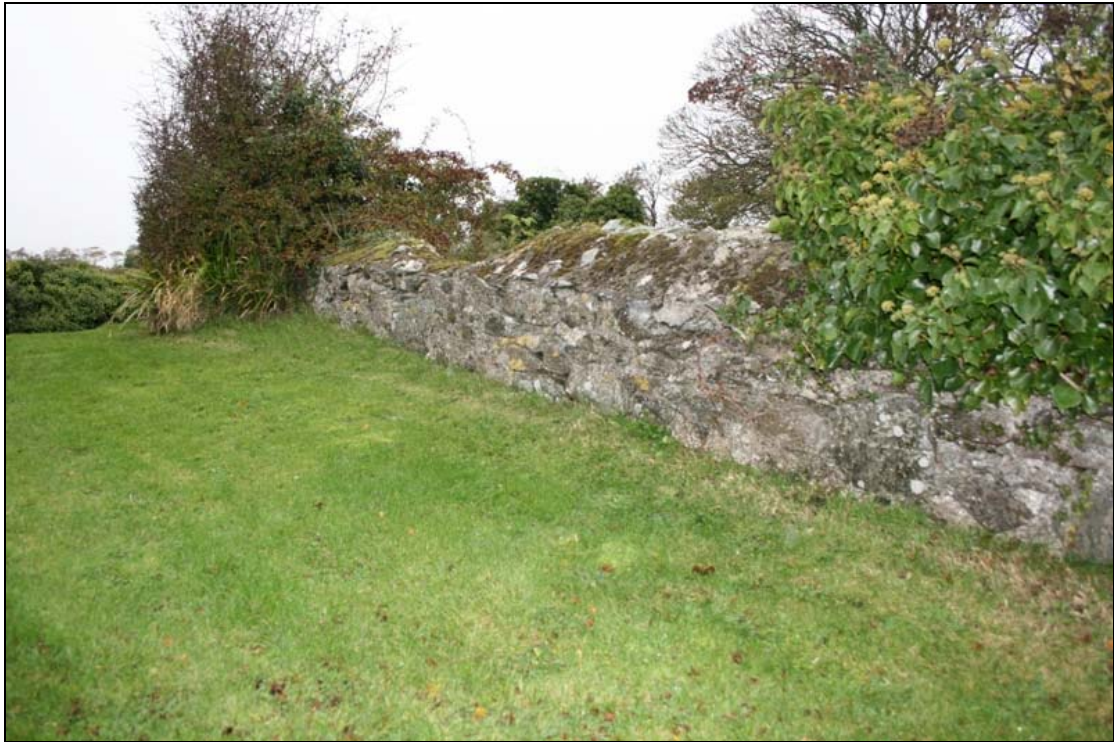
FHBS-10-BH-04 ~ North parapet from top of bridge
